2020 VOLKSWAGEN T-Cross

Reg: SAMPLE

Inspection Report No.:

991558

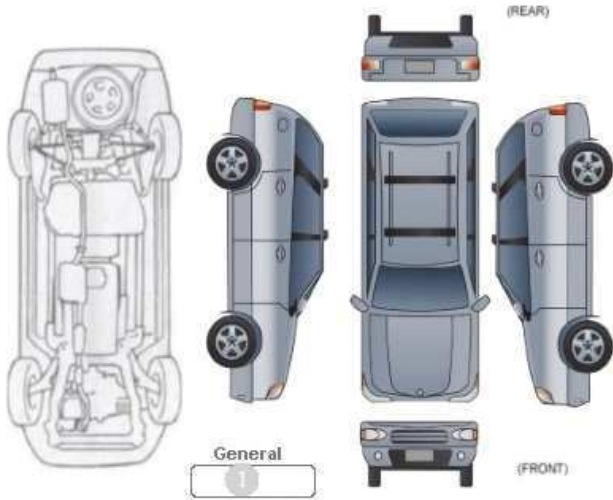
1

Bodywork in good condition, no defects noted.

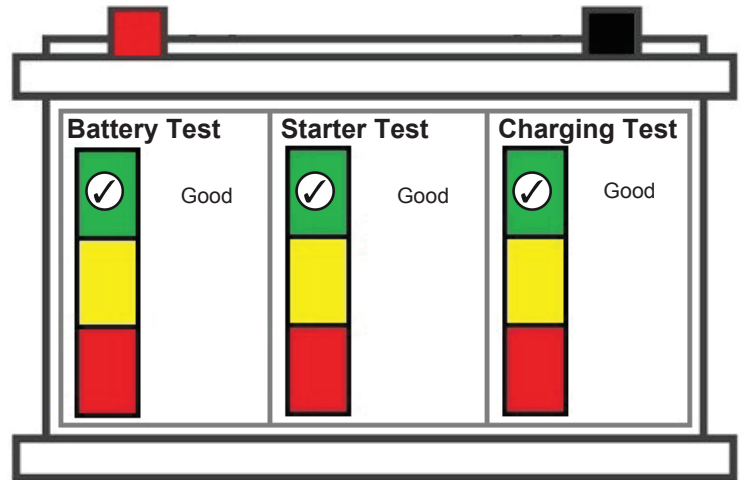
Good test results, no action required.
