Vehicle Appraisal

2002 HONDA CIVIC VI

Reg: TEST

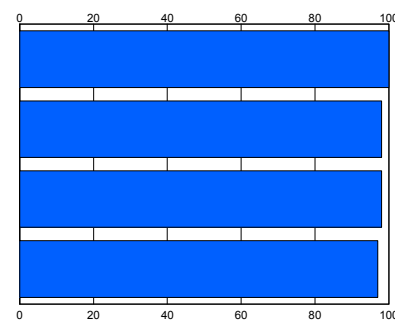
Relative Compression Test

Relative Compression Reading

Relative compression readings acceptable for age and mileage of vehicle
